Product affected
Colas / ILAS E

P/B No
005

Title / Subject
Solenoid Housing

Title / Subject
EB+ Leaking Modulator

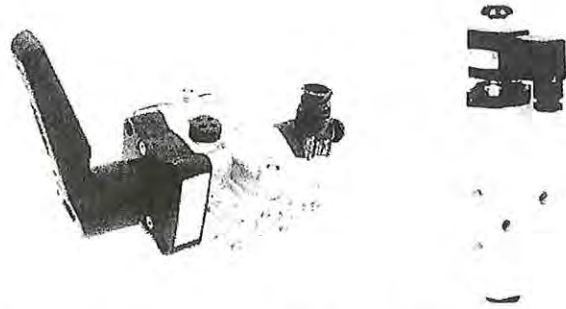
In many cases it is not necessary to change the complete valve due to problem with the solenoid or damage to the threads on the solenoid mounting plate. Spare solenoids with the mounting plates are available through the Haldex distributor network.

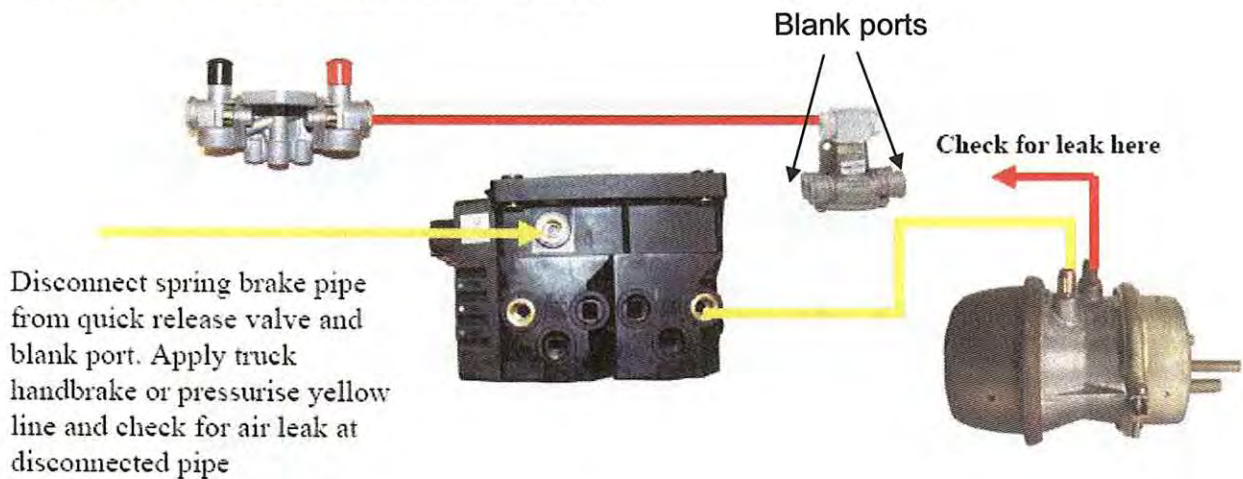
Valve leaking when truck handbrake applied

We have had several cases of reported leaking EB+ Modulator valves. However when the trailers have been inspected the cause has found to be a leaking spring brake chamber or in several cases multiple leaking brake chambers.

If the leak occurs when the truck hand brake is applied (Park on air truck) then the pipes going to the emergency side of the spring brake chamber should be removed from the QRV on a Gen 1 or the Spring brake feed ports on a Gen2. You can remove all the pipes at once if enough blanking plugs are available or 1 at a time. Once the pipe or pipes have been removed re-apply the handbrake and then check the pipe which is still connected to the brake chamber emergency side. Any air coming back through this pipe is leaking through the centre seal on the brake chamber and therefore the brake chamber will need to be replaced.

We would ask that before a valve is changed for a reported leak that the brake chambers are checked.

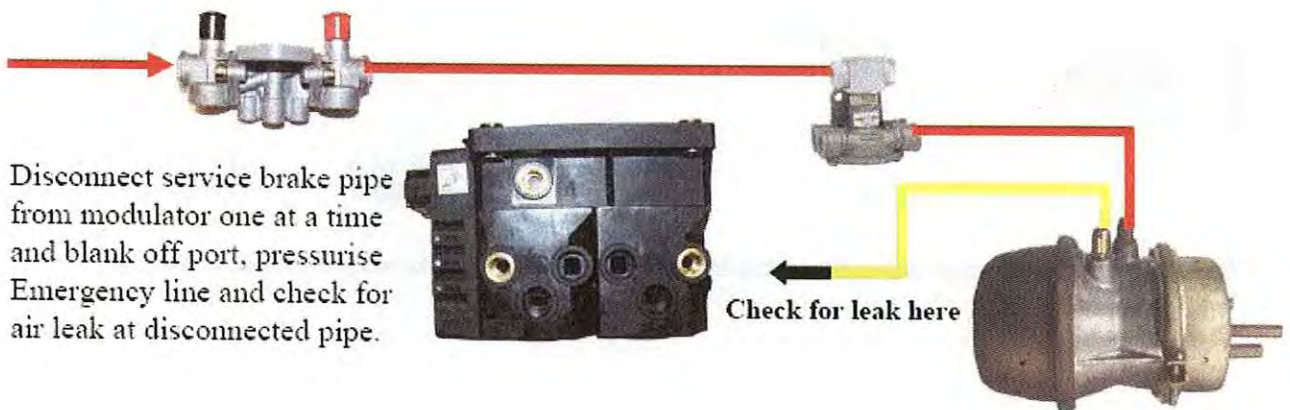
Valve leaking without handbrake applied

If the leak is present without the brakes applied then remove the pipes from the service ports in the EBS modulator and with red line connected check the removed pipes for any sign of air coming back through the pipe. Any air coming back through this pipe is leaking through the centre seal on the brake chamber and therefore the brake chamber will need to be replaced.

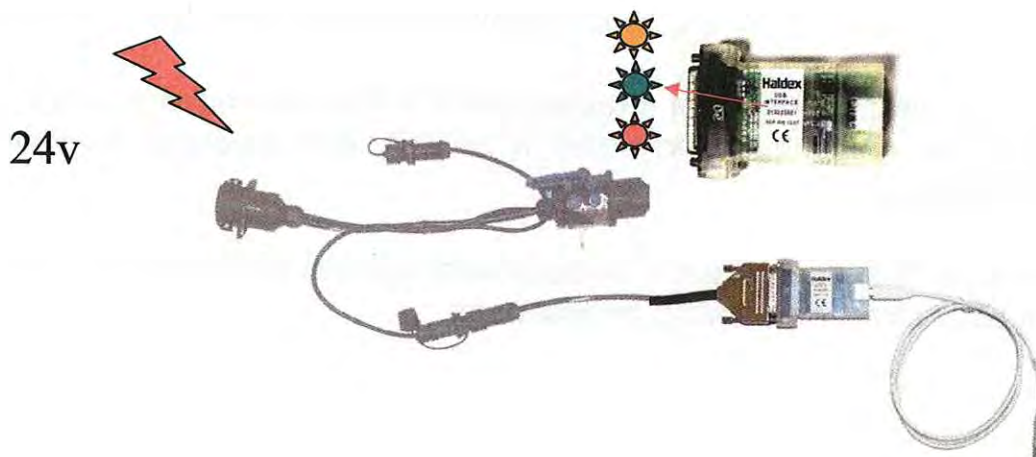
When using the Diag+ program, through the front of trailer ISO 7638 Headboard interface connector and USB Diag interface ensure that voltage used to power up EB+ ECU is **NOT** above 25v.

If voltage is above 25v there will be NO LINK to ECU, and the light on the interface will remain **RED**. It is therefore recommend to plug directly into ECU through the **Green** Diagnostic socket.

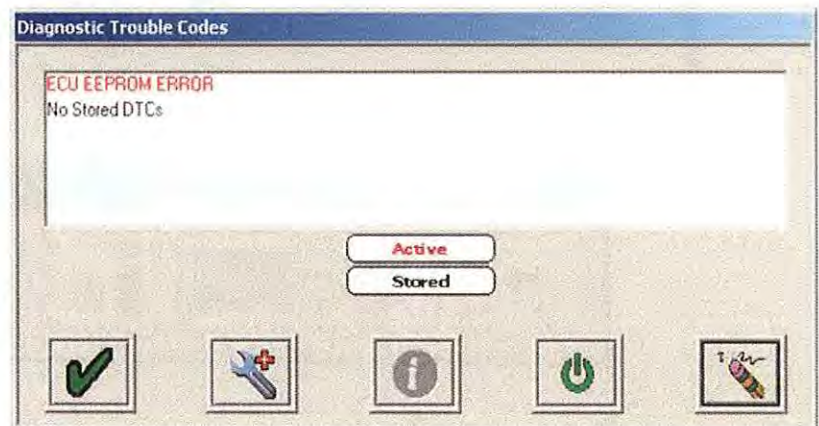
If this fault is flagged up as a diagnostic trouble code on an EB+ system, then first follow the steps below before changing the ECU or valve assembly.

It maybe that the ECU has been programmed using an early version of DIAG+ ECU set up file (i.e. V3.34) and has created an .elt file instead of a .dpf file.

1. Make sure that your lap top has the latest version of DIAG V5.12. (this can be downloaded free from website www.haldex.com)
2. Extract ECU set up file from ECU.
3. Read file.
- 4 Click on black arrow.
- 5 Each dialogue box will open (do not change anything).
6. Tick green arrow at bottom and the next box will open.
7. When all boxes have been ticked click on green tick at end.
8. Now send configuration into the ECU and return back to main screen.

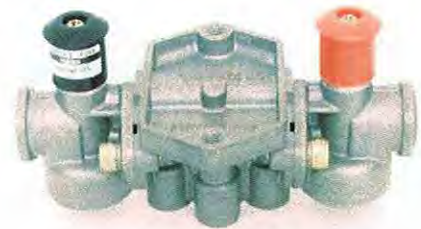
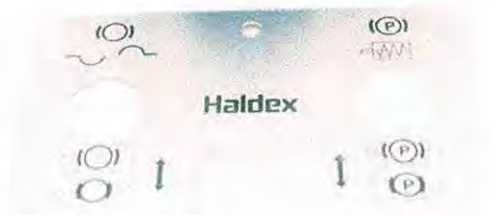
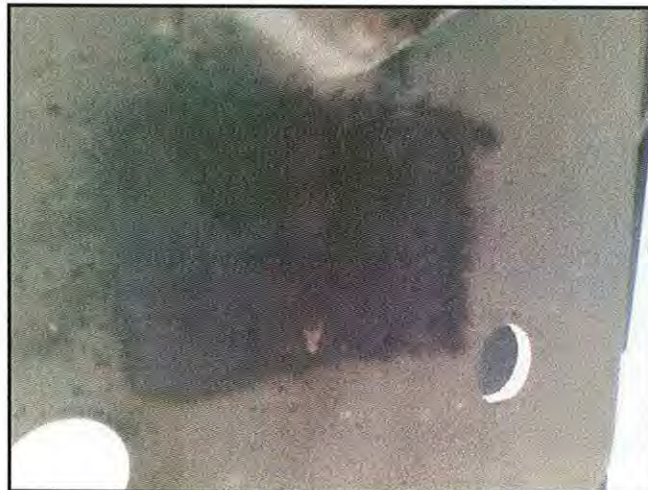
We have had a number of failures where the non return valve in port 11 has become stuck and stops air being delivered to the trailer air tanks. The EBS warning lamp will come on in the cab once the trailer air tank drops to 4.5B.

In all the returned units the reason for the failure has been oil contamination which has caused the rubber part of the non return valve to swell. Below is a photo showing the amount of oil present in one trailer, the air tank pipe was removed from port 11 with full air tank pressure and we were able to spray the area shown on the main beam with oil.

We are no longer prepared to accept these returns as warranty as the valve is being subjected to contamination which is being delivered from the truck.

We are prepared to offer a small quantity of parts free of charge for those who wish to repair these contaminated valves. (Contact Haldex Technical direct.)
