Product affected
Colas / ILAS E

P/B No
005

Title / Subject
Solenoid Housing

Title / Subject
EB+ Leaking Modulator

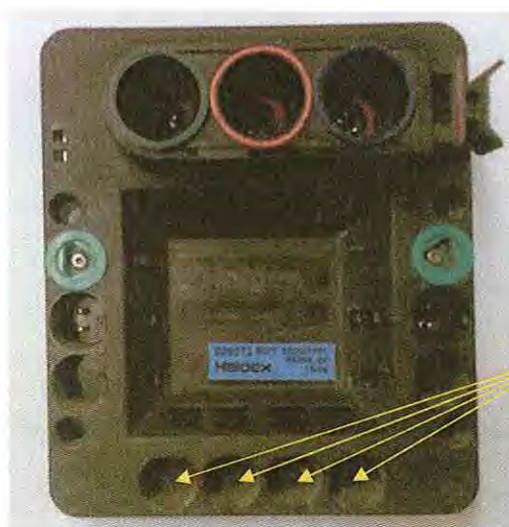
Example of 1 Auxiliary
EB+ ECU

The standard EB+ ECU has 5 Auxiliaries, but we also offered a 1 Auxiliary version on 2S/1M systems (as shown below) and a 3 Auxiliary version on 2S/2M systems. As we introduced new software features we have found a potential issue on ECU's with a reduced number of Auxiliaries when running on B399 or higher software. If the air bellow pressure is above approx 4.1B and the ignition is reset there will be a **Configuration error Aux 4** fault generated. Once the bellow pressure reduces below 4.1B and the ignition is reset then the fault is no longer active but will become stored.

Auxiliary ports blank

You will need to read the data from ECU and then go to the Aux configuration menu. In this menu select Aux 4 and program to **General Purpose Input**. Once selected re send the information back to the ECU and check that there are no other faults present. (See screen shot below)

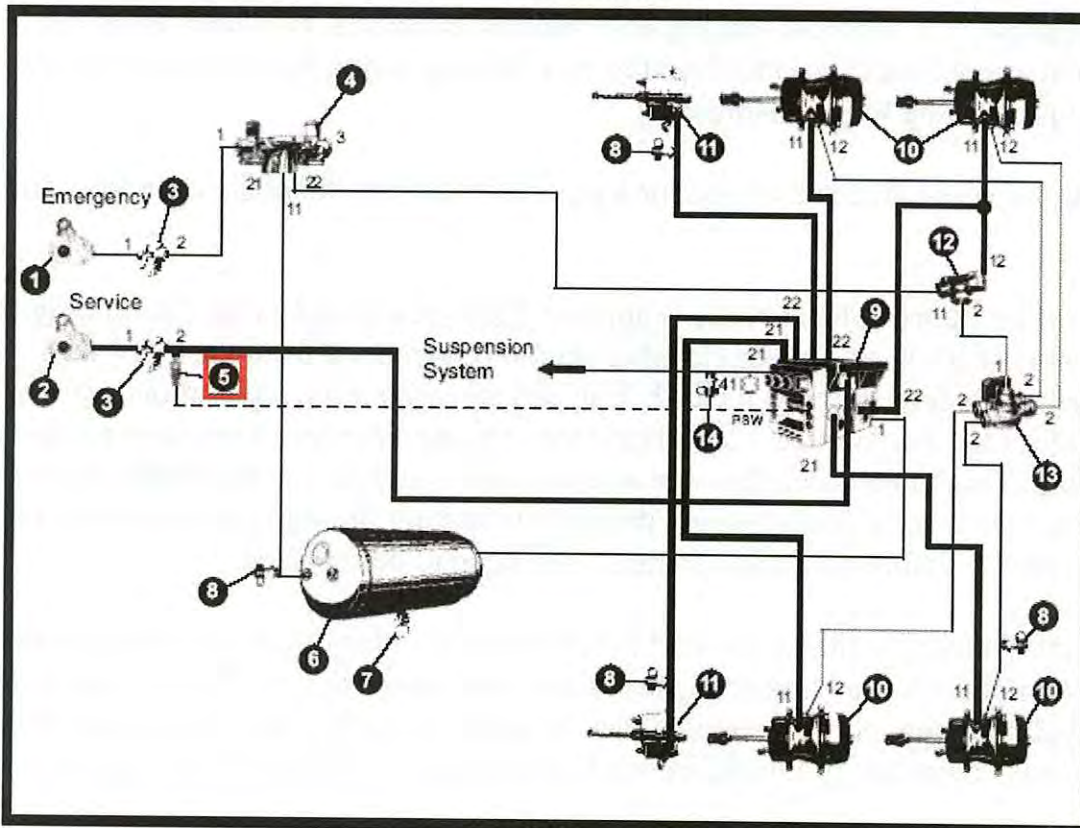
Fig. 86

We have had several cases of reported leaking EB+ Modulator valves. However when the trailers have been inspected the cause has found to be a leaking spring brake chamber or in several cases multiple leaking brake chambers.

We would ask that before a valve is changed for a reported leak that the brake chambers are checked.

If the leak occurs when the truck hand brake is applied (Park on air truck) then the pipes going to the emergency side of the spring brake chamber should be removed from the QRV on a Gen 1 or the Spring brake feed ports on a Gen2. You can remove all the pipes at once if enough blanking plugs are available or 1 at a time. Once the pipe or pipes have been removed re-apply the handbrake and then check the pipe which is still connected to the brake chamber emergency side. Any air coming back through this pipe is leaking through the centre seal on the brake chamber and therefore the brake chamber will need to be replaced.

If the leak is present without the brakes applied then remove the pipes from the service ports in the EBS modulator and with red line connected check the removed pipes for any sign of air coming back through the pipe. Any air coming back through this pipe is leaking through the centre seal on the brake chamber and therefore the brake chamber will need to be replaced.

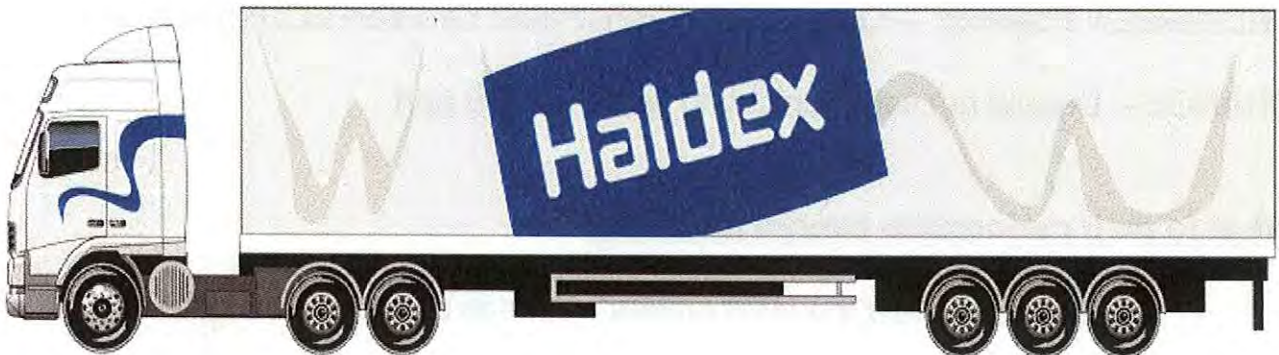
Diag+ Connection

When using the Diag+ program, through the front of trailer ISO 7638 Headboard interface connector and USB Diag interface ensure that voltage used to power up EB+ ECU is **NOT** above 25v.

If voltage is above 25v there will be NO LINK to ECU, and the light on the interface will remain **RED**. It is therefore recommend to plug directly into ECU through the **Green** Diagnostic socket.

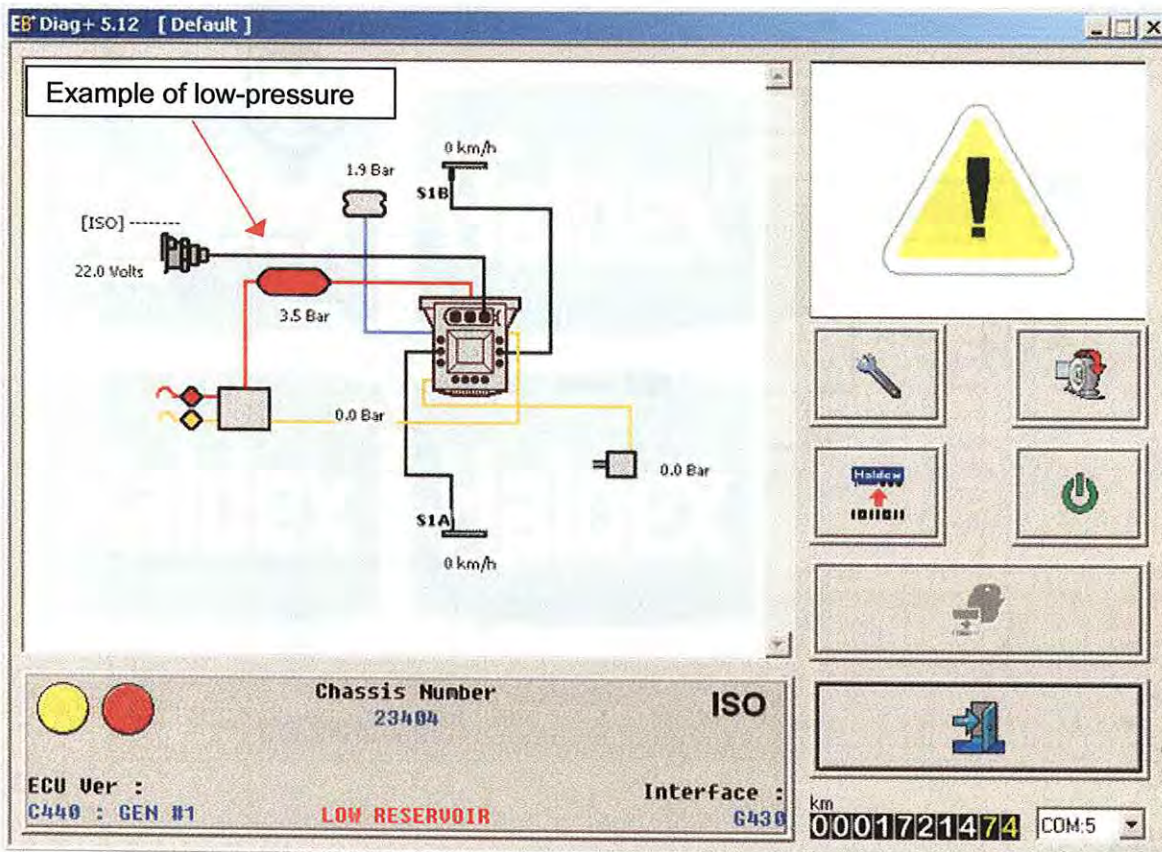
Low Pressure

If the air reservoir on the trailer is below 4.5B then you will have a lamp on in the truck. Connecting the laptop and you will have an air gauge alternating with the warning triangle and a message of **Low reservoir**. As can be seen below the air reservoir only reads 3.5B, once it reaches 4.5B the lamp will go out and the Haldex Logo will return to the screen.

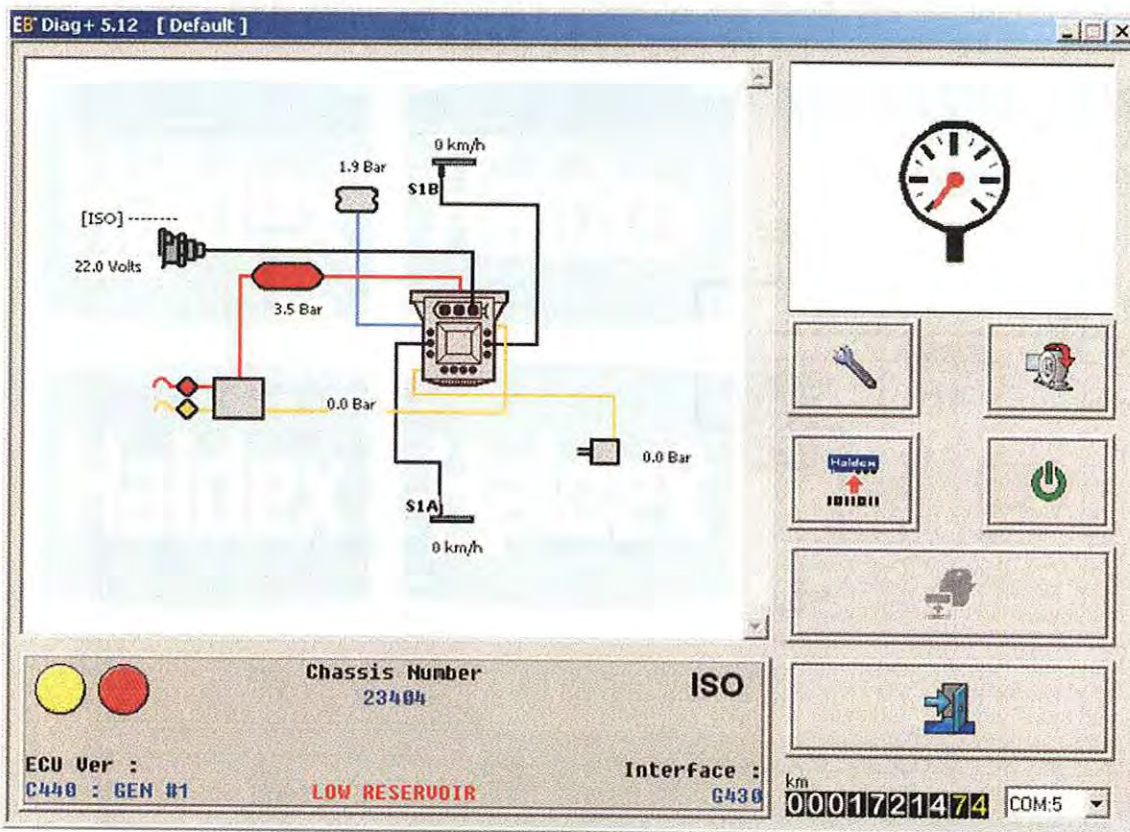
Checks to carry out if the lamp remains illuminated once the air was been fully charged on tractor unit;

1. Check the single check valve function in combined park and shunt 352 046 001 see Product Bulletin 007.
2. Using a pressure gauge connected direct to tank, check pressure, if pressure in tank is more than what reading is shown on screen then possible faulty reservoir pressure transducer inside valve block.
3. Make sure the valve lifter on the coupling is operating and check for any kinked pipes.

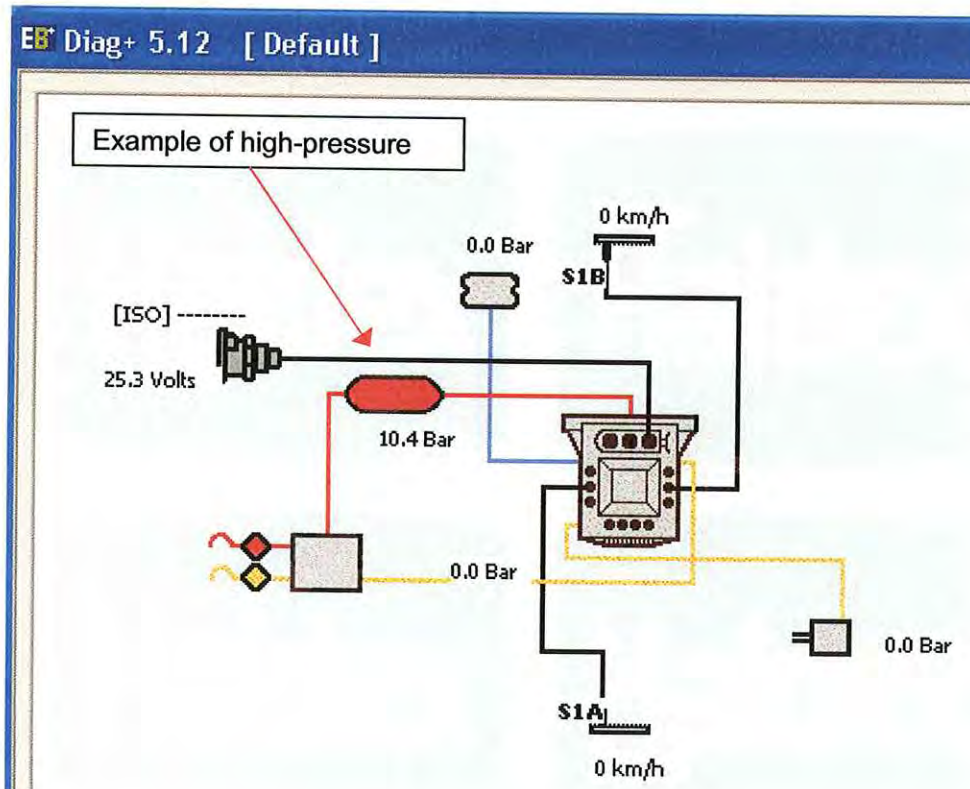
High Pressure

Exactly the same will happen when the air reservoirs on the trailers reach above 9.75B, you will get a lamp on in the cab and when connected to Diag+ you will see the same information as Low

On later levels of software we have now introduced at DTC of High Res Pressure and this will be stored.

The truck will have to be limited to 8.5B which is the legal maximum for a trailer.
